2008–2012 Reported Circulation/Suction Entrapments Associated with Pools, Spas, and Whirlpool Bathtubs, 2013 Report

March 2013

Kevin Gipson
Directorate for Epidemiology
Division of Hazard Analysis
U.S. Consumer Product Safety Commission
4330 East West Highway
Bethesda, MD 20814

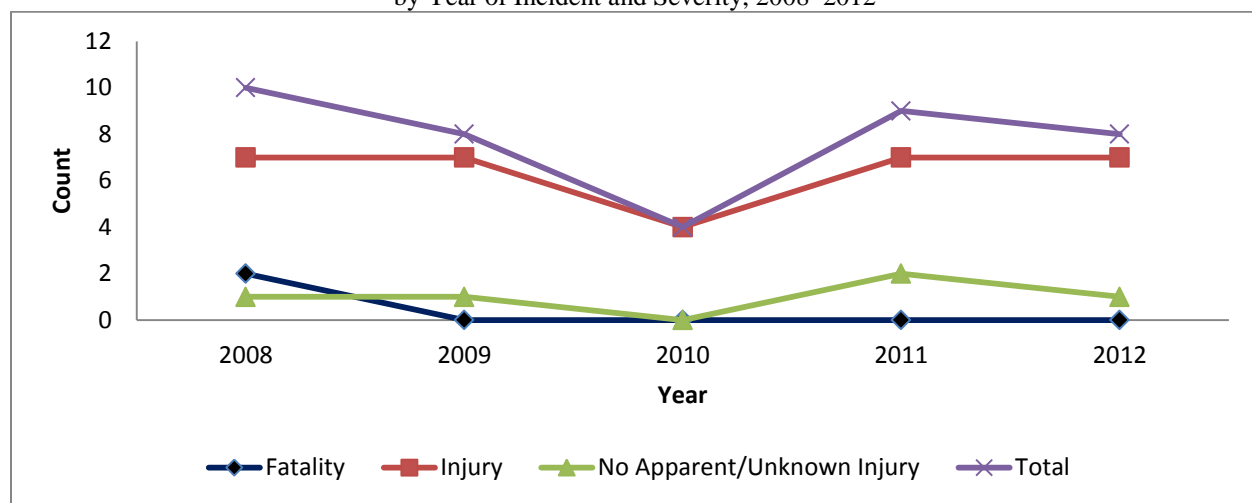
Figure 1
Reported Circulation Entrapments Associated with Pools, Spas, and Whirlpool Bathtubs
by Year of Incident and Severity, 2008–2012

Source: CPSC databases, including NEISS (National Electronic Injury Surveillance System), IPII (Injury and Potential Injury Incidents), DTHS (Deaths), and INDP (In-Depth Investigations). Data extracted and entrapment database updated in January 2013. Reporting is ongoing for all of these years.

There were 36 reports (39 victims) concerning circulation entrapments for the period 2008 through 2012. Of the 36 reports, three reports each involved two victims. Appendix A gives the methodology for data extraction and updating the database and Appendix B gives a summary of the 36 reports. For this time period, there were 2 fatalities² (both in pools), 32 injuries (14 pool, 11 spa, 7 whirlpool bathtub), and 5 no apparent injury or unknown injury incidents (2 pool, 2 spa, 1 whirlpool bathtub). Both fatalities occurred in 2008. Figure 1 displays the yearly counts of reported victims based on severity (fatality, injury, and no apparent/unknown injury).

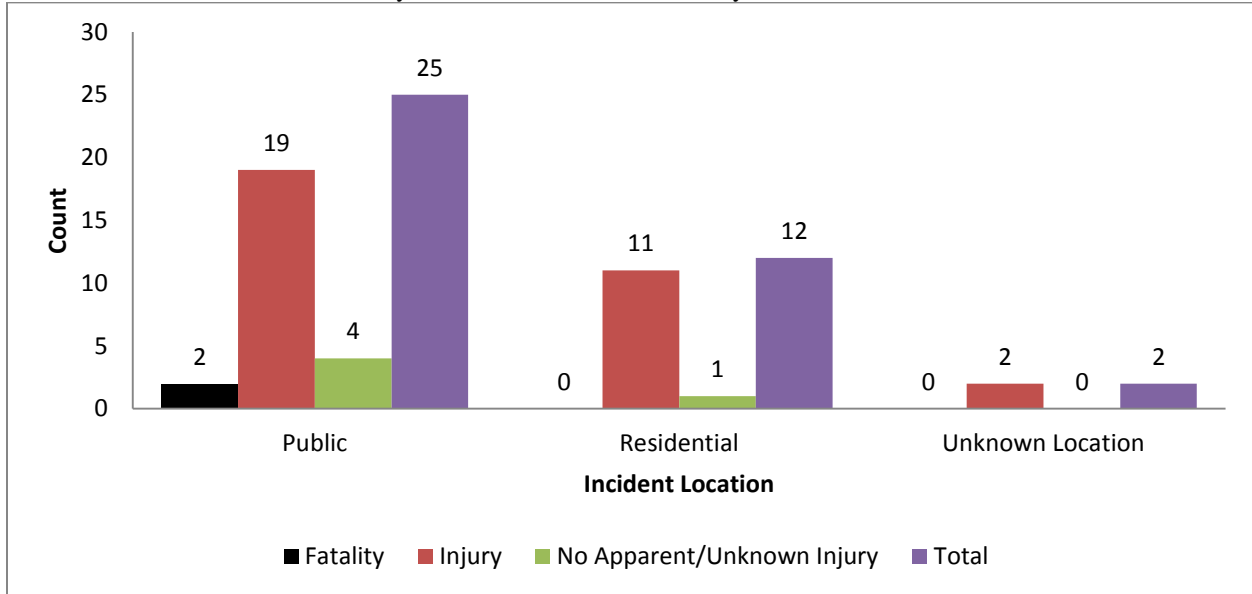
Figure 2
Reported Circulation Entrapments Associated with Pools, Spas, and Whirlpool Bathtubs
by Incident Location and Severity, 2008–2012

Source: CPSC databases, including NEISS, IPII, DTHS, and INDP. Data extracted and entrapment database updated in January 2013. Reporting is ongoing for all of these years.

The majority of the incidents (25 victims, 64 percent) occurred in public locations. Figure 2 presents the frequency of reported victims by location and severity.

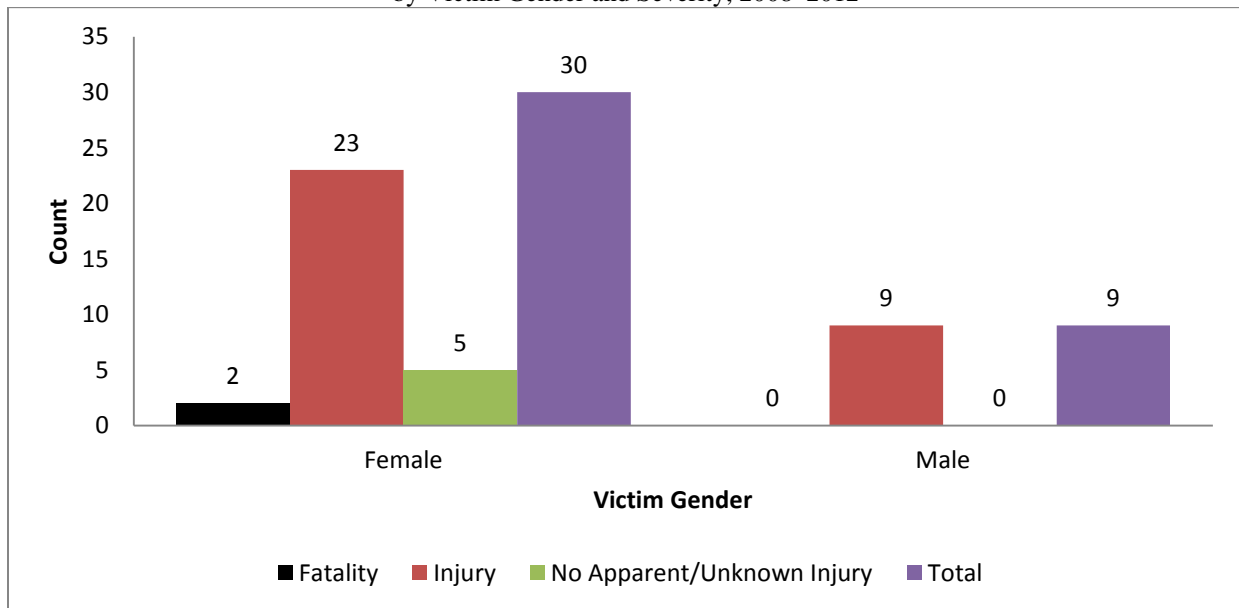
Figure 3
Reported Circulation Entrapments Associated with Pools, Spas, and Whirlpool Bathtubs
by Victim Gender and Severity, 2008–2012

Source: CPSC databases, including NEISS, IPII, DTHS, and INDP. Data extracted and entrapment database updated in January 2013. Reporting is ongoing for all of these years.

More females (30 victims, 77 percent) were involved in these incidents compared to males (9 victims, 23 percent). Figure 3 displays circulation entrapment counts for reported entrapments by gender and severity.

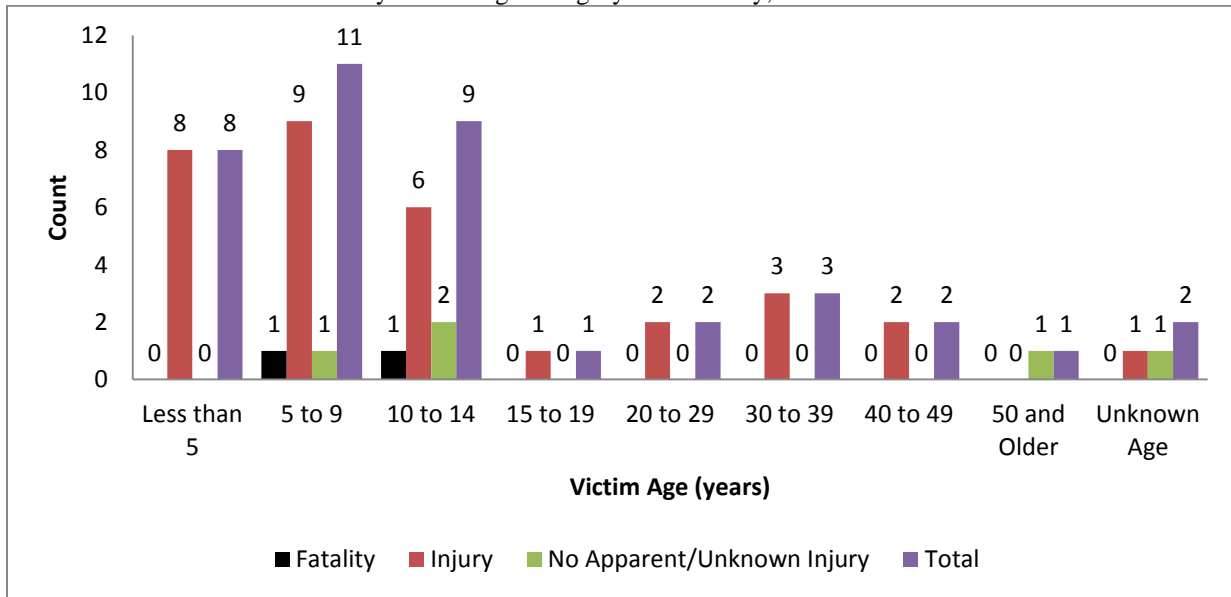
Figure 4
Reported Circulation Entrapments Associated with Pools, Spas, and Whirlpool Bathtubs
by Victim Age Category and Severity, 2008–2012

Source: CPSC databases, including NEISS, IPII, DTHS, and INDP. Data extracted and entrapment database updated in January 2013. Reporting is ongoing for all of these years.

Figure 4 gives the counts of reported victims by victim age category and severity. Children in the 5- to 9-year-old category have the highest frequency (11 victims, 28 percent) of circulation entrapments. This is followed by the 10- to 14-year-old (9 victims, 23 percent) and younger than 5-year-old (8 victims, 21 percent) categories. Children 14 years of age or younger were involved in 28 (72 percent) of the reported circulation entrapments.

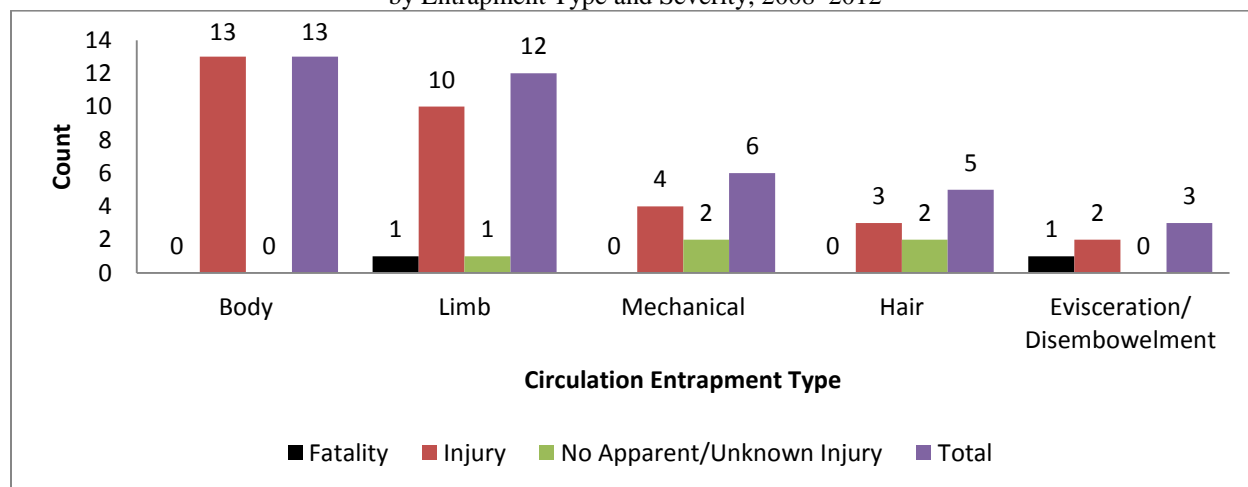
Figure 5
Reported Circulation Entrapments Associated with Pools, Spas, and Whirlpool Bathtubs
by Entrapment Type and Severity, 2008–2012

Source: CPSC databases, including NEISS, IPII, DTHS, and INDP. Data extracted and entrapment database updated in January 2013. Reporting is ongoing for all of these years.

The incidents reported to CPSC staff identified body (13 victims, 33 percent) and limb (12 victims, 31 percent) entrapment as the most frequent type of entrapment. This is followed by mechanical (6 victims, 15 percent) and hair (5 victims, 13 percent) entrapment, and finally eviscerations/disembowelments⁴ (3 victims, 8 percent). Figure 5 displays circulation entrapment victim data by entrapment type and severity.

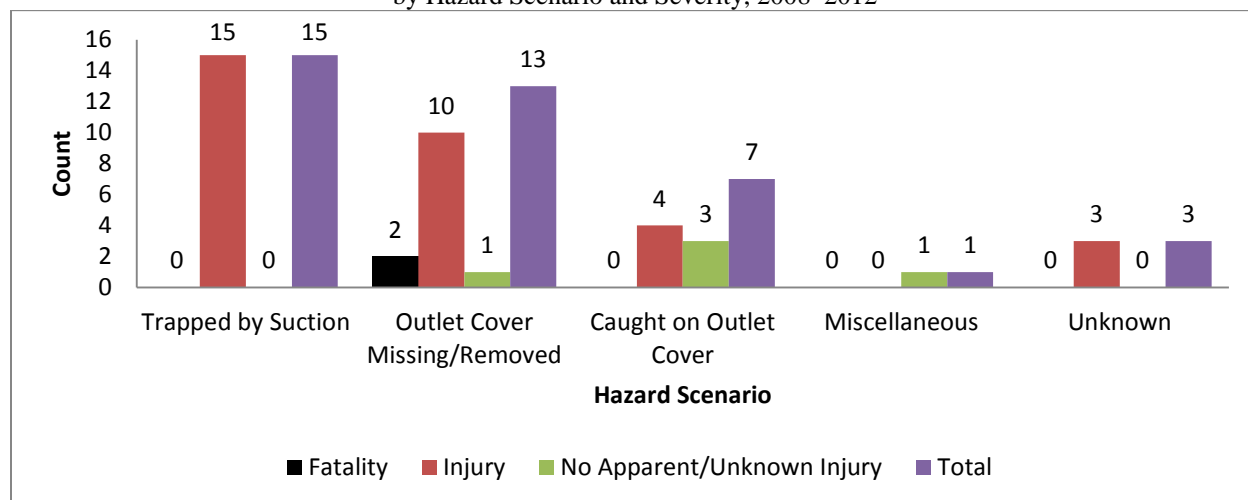
Figure 6
Reported Circulation Entrapments Associated with Pools, Spas, and Whirlpool Bathtubs
by Hazard Scenario and Severity, 2008–2012

Source: CPSC databases, including NEISS, IPII, DTHS, and INDP. Data extracted and entrapment database updated in January 2013. Reporting is ongoing for all of these years.

Many of the incidents (15 victims, 38 percent) involved scenarios where the victim was being held to the drain by the suction force. Another large portion (13 victims, 33 percent) involved issues with missing or removed outlet covers. An additional set of incidents (7 victims, 18 percent) involved the victim being caught on the outlet cover. One incident was classified as “miscellaneous” because although the scenario was known, the scenario did not fit into the other categories. The remaining incidents (3 victims, 8 percent) did not provide sufficient details to categorize the hazard scenario. Figure 6 enumerates the results of the hazard scenario categorizations for circulation entrapments related to pools, spas, and whirlpool bathtubs.
